CASE STUDY

Steel Mill Ladle Transfer Car

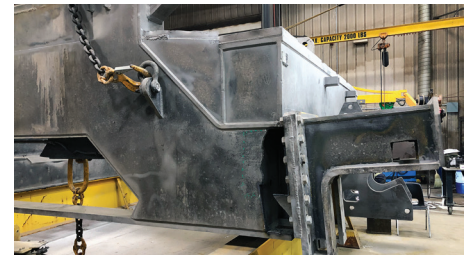
- Steel mill ladle transfer car was structurally damaged and removed from operation due to safety and reliability concerns

- A full teardown and inspection was performed, including frame cut to internally inspect the integrity of the frame
- The inspection revealed significant damage to the car frame and several components in the drive system, as well as a weakness in the frame design

- The Inspection Report proposed repairs to the damages areas of the structure and the replacement of the gearbox, shafts, and coupling hubs for the transfer car drive
- All recommended repairs were highlighted for the customer, including the fixed pricing for each line item

- ✓ **Total Cost of Ownership**
Brandt performed the proposed repairs with minimal production down time, and returned this ladle transfer car to safe operating condition for less than 65% of the new cost
- ✓ **Reliability**
The improved frame design resulted in a longer mean time between failures (MTBF)
