CASE STUDY

# Road Header Conveyor

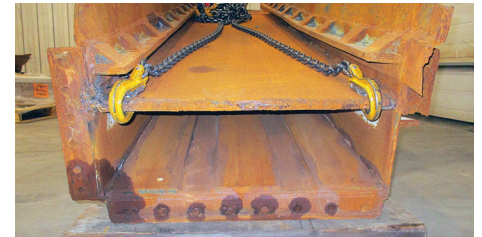
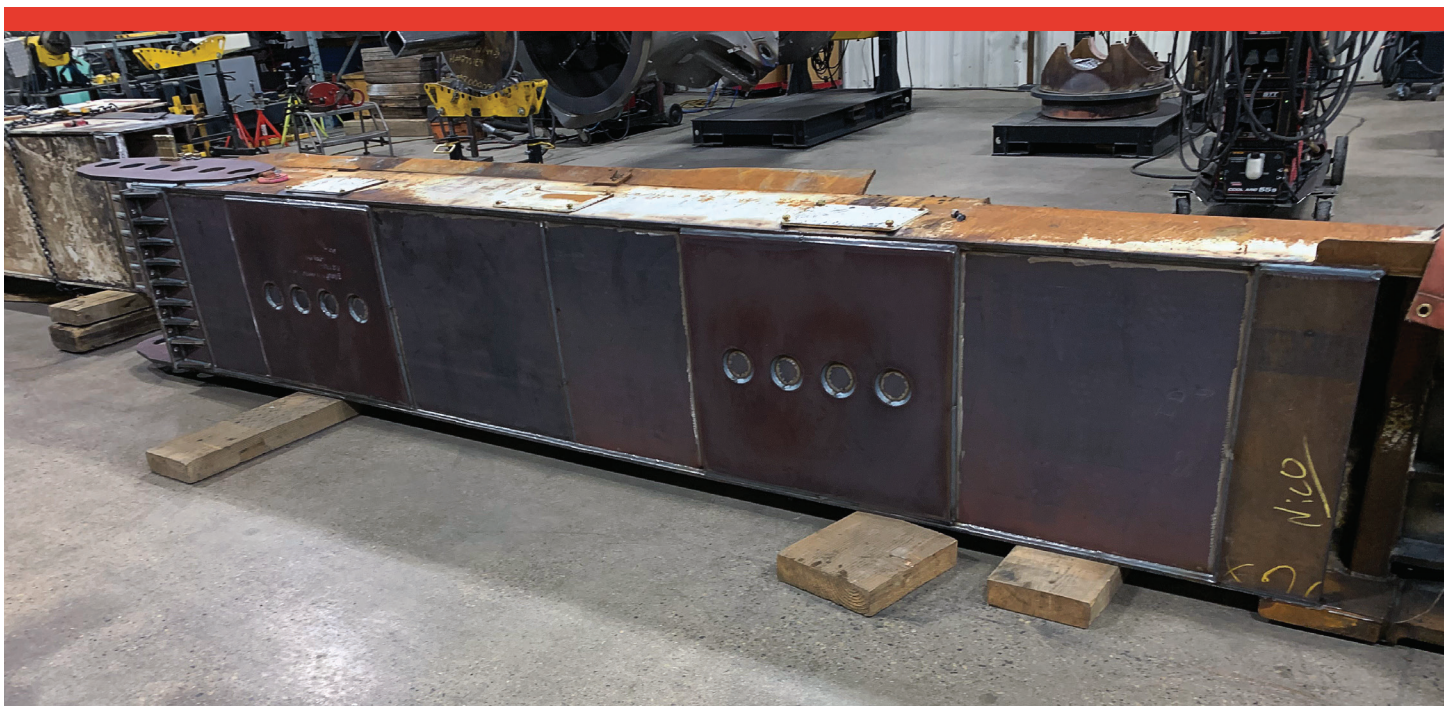
- The center conveyor connection point was failing during operation due to a build-up of debris (muck) under the conveyor

- Structural failures were also causing increased wear in the forward section of the conveyor
- Brandt provided a repair plan including recommended design improvements

- ✓ **Total Cost of Ownership**  
Replaced all damaged areas and upgraded the structure for a lower cost than an OEM replacement
- ✓ **Reliability**  
Delivered a robust flange including reinforcement in the failure areas resulting in reduced unplanned downtime
- ✓ **Safety**  
Provided the owner detailed instructions for the on-site assembly and welding, ensuring both a safe and accurate installation
